Bihar Floods: The Inevitable Has Happened

DINESH KUMAR MISHRA

The overflowing Kosi had, as of end-August, wreaked destruction on more than three million people living in north and east Bihar. A field visit reports on the misery of the affected, haphazard rescue efforts and criminal exploitation of the uprooted. The immediate task is to improve relief operations and then provide support to the displaced who will not be able to find work until the 2009 kharif season. A blame game is now in operation, but since the early 1960s whichever the party in power, the people of Bihar have been affected by official apathy towards the embankments on the Kosi. This time it is a clear case of dereliction of duty by the state government in repairing upstream barrages before the monsoon of 2008 that has resulted in devastation.

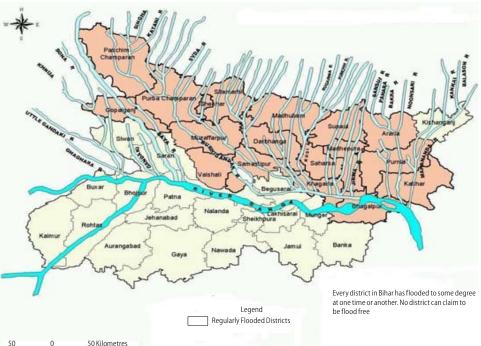
Map 1: Flooding in Bihar

Sources: Relief and Rehabilitation Department, GoB, Central Water Commission, Bihar Media reports, Daily Reports from the districts.

[Map 1 has been reproduced from the article 'Gerrymandering, Poverty and Flooding: A Perennial Story of Flooding' by J Albert Rorabacher, EPW, February 16, 2008.]
